Damage Quantification from Point Clouds for Finite Element Model Calibration

Mohammad Ebrahim Mohammadi¹, Seyedsina Yousefianmoghadam², Richard L. Wood³,
Andreas Stavridis⁴

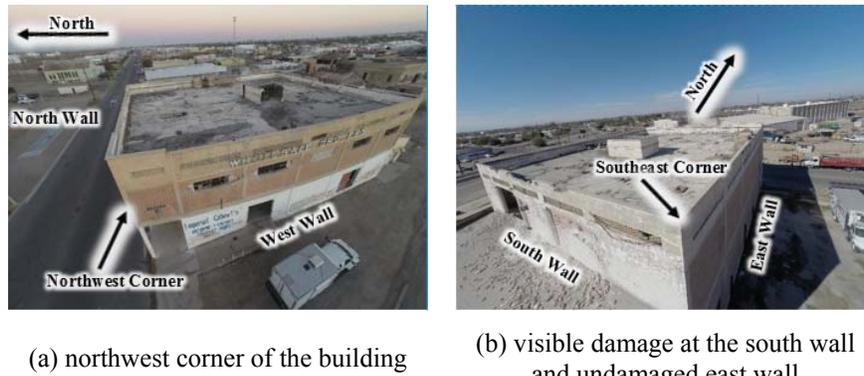
The focal point of this study is the building shown in Fig. 1, located in El Centro, California. The two-story building was built in the 1920s, has an overall length of 39 m in the north-south direction, 26.5 m in the east-west direction, and a maximum height of 11.8 m. The building comprises of six reinforced concrete structural frames in the north-south direction connected with reinforced concrete joists in the east-west direction which are connected via a one-way floor slab. The upper story walls are comprised of two single wythe independent masonry infills, while the first floor has three types of infill: reinforced concrete panels, unreinforced masonry panels, and the combination of these two construction styles. This building was subjected to four significant earthquakes. The most recent earthquake, the 2010 El Mayor – Cucapah Earthquake, caused significant structural damage to the building, which was subsequently red-tagged for demolition. The masonry infills of the north and west bays experienced significant shear cracking which led to damage of the RC columns. In addition, the infills in four out of five bays in the south wall partially or fully collapsed.

Fig. 1 Imperial Cabinet building aerial views following the 2010 El Mayor-Cucapah earthquake.

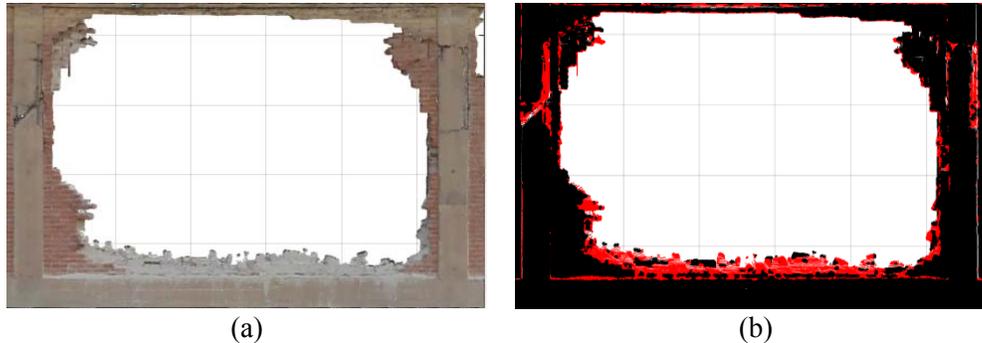
To quantify the potential surface damage of a structure, variations of the surface geometry proposed in the literature [e.g. 2, 3] are incorporated herein. In this study, surface damage and defects are quantified using an average weighted variation of the surface normals. To compute the normal vector for a point, n neighboring points are triangulated to form $n(n - 1)/2$ regions. Then an average weighted normal vector is computed over this area. [4] To estimate the variation of these normals, the relative angle is computed with respect to a least squares regression reference plane for each wall. As the angle increases from zero, a greater variation in the surface geometry is indicated. It should be noted that the change in the surface geometry (where the angles differs from zero) can represent both surface damage of the structure as well as architectural features. An application example of this methodology is provided in Fig. 3b in which the vertices with the highest relative angle to the reference plane are highlighted in red. Referring to the colorized scan in Fig. 3a, the red points indicate surface damage including cracks, concrete spalling, and unstable bricks at the interface of the collapsed wall.

Fig. 3 Single bay of second floor at the west wall of the building after the test: (a) the colored point cloud and (b) detected damage shown by red (grey in black and white prints) color.
