# Post-Fire Damage Geospatial Assessment via Point Clouds of a Highway Bridge Structure

**ABSTRACT:** This paper discusses the quantitative post-fire damage assessment of a steel girder bridge via point clouds. In this case study, the point cloud was collected using light detection and ranging (lidar) for a detailed geometric and shape analysis. The out-of-plane deformation was analyzed to locate and quantify buckling across the length of the steel girders.

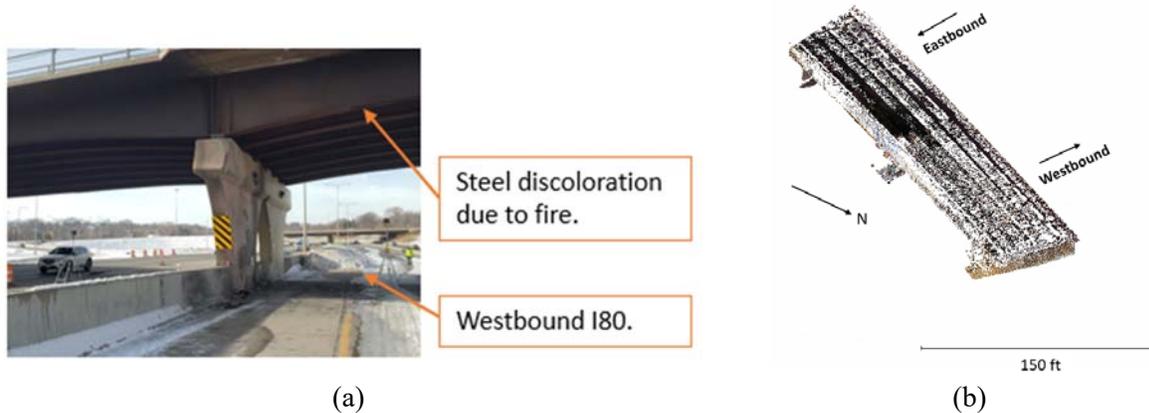
On Friday, June 1<sup>st</sup>, 2018, a vehicle caught fire on the I-80 westbound shoulder directly adjacent to the north side of the pier of the 10th street bridge in Omaha, Nebraska. The fire caused damage to the I-80 westbound pavement, barrier rail, north face of the bridge pier, steel girders and cross-frames of the superstructure, bridge deck, and utilities attached to the bridge (Figure 1a). Visual assessment was conducted following the event with observations including out-of-plane buckling of the steel girders as well as spalling and cracking of the concrete deck and pier. However, the visual damage assessment was not able to quantify the various damage patterns, nor indicate the extents of the damage along the girders due to the complex geometry of the structure [1]. Therefore, this study collected detailed geometric data using light detection and ranging (lidar) technology to analyze the complex buckling patterns of the bridge girders guide possible interventions.

Figure 1. The case study structure: (a) bridge view including lidar scanners deployed for point cloud collection, and (b) isometric view of aligned point cloud.

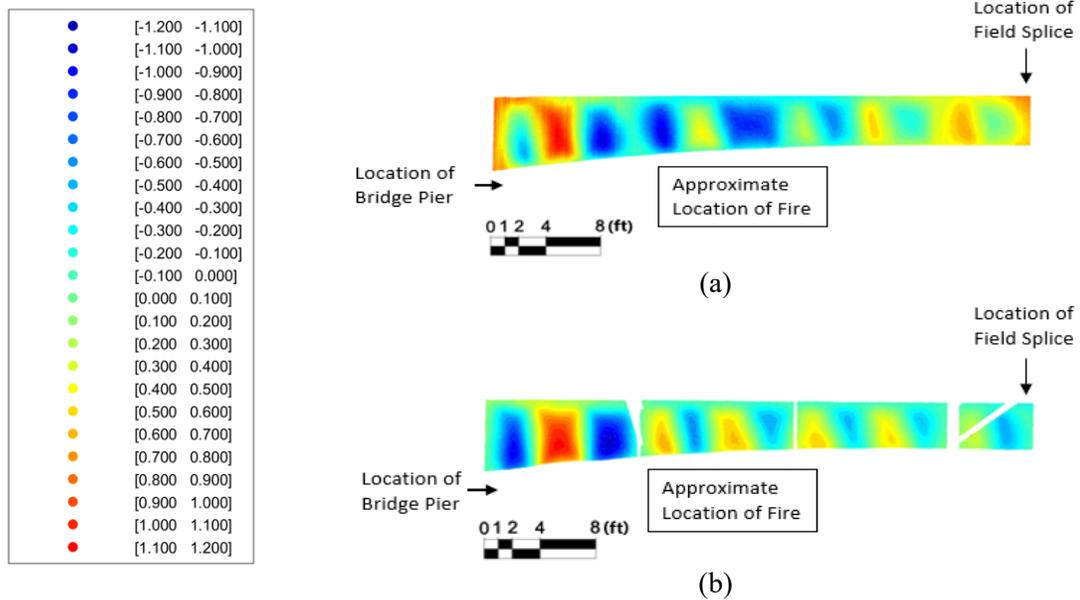
Girder I.D.	Westbound (inch)				Eastbound (inch)			
	Min.	Max.	Median	Range	Min.	Max.	Median	Range
Eastmost	-1.09	1.20	-0.02	2.29	-0.74	0.43	-0.02	1.17
2 <sup>nd</sup> Eastmost	-1.15	1.11	-0.01	2.26	-0.61	0.28	0.01	0.89

The visualization of the depth-map analysis enables the identification of the locations of maximum and minimum out-of-plane-deformation as well as its distribution throughout the girder web. As shown in Figure 2, the two girders underwent a severe deformation due to the elevated temperatures, where they experienced a total deformation (range from the minimum to the maximum) in excess of 2.2 inches approximately at the distance of 3.5 ft from the pier, respectively. In addition, the depth-map visualization indicates that second eastmost sustained additional localized deformations with maximum magnitudes in excess of 1.1 inches throughout its length up to the field splice in both out-of-plane directions. The eastmost girder sustained a localized out-of-plane deformation with a maximum magnitude of 1.2 inches, with respect to the reference plane, in the vicinity of the pier with additional localized deformation near the field splice. Similar analysis and results were detailed on other girders in both the eastbound and westbound lanes as well as select cross-frames [1].

Figure 2. Depth map analysis results (in inches) on the westbound span (a) eastmost girder, (b) second eastmost girder.
