Monitoring of the Sunrise Movable Bridge

Mustafa Gul¹ and F. Necati Catbas²

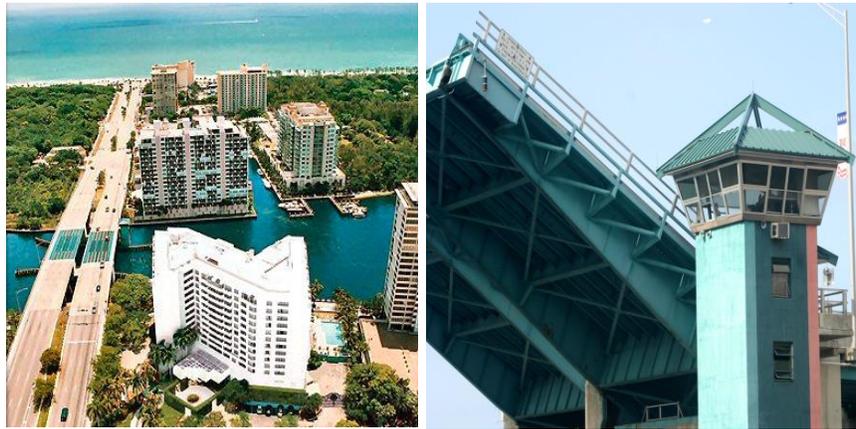
Figure 1. Sunrise Bridge in Ft. Lauderdale, FL

In this section, the design and implementation of a monitoring system on the Sunrise Movable Bridge in Ft. Lauderdale (Figure 1) is presented. The selected representative movable span (constructed in 1989) is the west-bound span of two parallel spans on Sunrise Boulevard in Ft. Lauderdale (Catbas et al. 2009) [3]. It has double bascule leaves, with a total length of 117 ft, width of 53.5 ft each 70-ft long, and 40-ft wide, carrying three traffic lanes. The bridge opens every 30 minutes when requested and about 10 times a day.

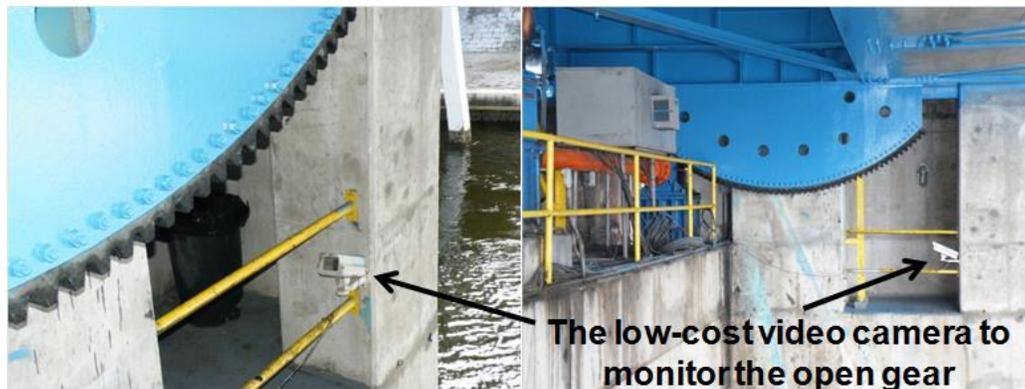
Figure 2. The open gear of the movable bridge and the video camera for lubrication monitoring

The open gears are the main gears, which are parts of the leaf main girder, receiving the torque from the rack and pinion assembly. Excessive strain, out-of-plane rotation, and misalignment are common problems for open gears. Another concern is loading sequence problems, which mean that the drive shafts begin their rotation in a delayed sequence. This has an adverse effect on the condition of the open gears, usually by causing impact loading. To mitigate all these and related problems, routine maintenance is required on the gear teeth. Unless they are kept properly lubricated at all times, wear and corrosion due to grinding of the rack and pinion will occur. One of the open gears of the movable bridge and the camera used for monitoring are shown in Figure 2.

For the open gear tests, the lubrication of the open gear was removed and it was not maintained intentionally for about 6 weeks. The image data from regular operation as well as from low lubrication operation was collected. The 6-week low lubrication period was not enough to have corrosion on the gears however regular lubrication was started after 6 weeks due to safety reasons. However, a set of valuable monitoring data for the evaluation of the proposed methods could still be collected from this monitoring period: 1) baseline well-maintained condition 2) removal of grease and no maintenance for 6 weeks, and 3) finally after the maintenance of the open gear. Finally, a second data set was also collected for verification purposes. During this period (approximately two months), the open gear was properly lubricated. Preliminary review of several recorded images showed that the grease chunks in the properly lubricated open gear were visually detectable whereas the low lubrication cases did not show these grease chunks. Therefore, it was proposed by the authors that an edge detection methodology would identify more edges for the proper lubrication cases because of the grease chunks. More details about the methodology can be found in [5].
