Structural Health Monitoring of Bridge Abutments using Imaging Radar and Digital Image Correlation

ABSTRACT: In this study, a local composite bridge was monitored by portable sensors (an imaging radar sensor and a digital image correlation (DIC) sensor) for surface and subsurface sensing of bridge abutments. The combination of radar (subsurface) and DIC (surface) enables civil engineers to monitor bridge abutments in a multiphysical approach, allowing changes of different nature in bridges to be detected. From our experimental result, locations of subsurface steel rebars are detected by the imaging radar sensor, as well as changes in surface displacement and stress distribution are reconstructed by the DIC sensor.

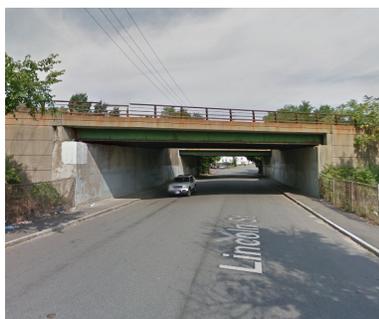
(a) L-15-74 bridge

A local bridge (L-15-74) in the City of Lowell, MA on the Lowell Connector (U.S. Highway 3) and crossing Lincoln Street was selected for the monitoring effort. Fig. 1 shows the location and a picture of the bridge. As shown in Fig. 1, there are two structures of the bridge; the northbound section and the southbound section. Bridge abutments of both sections were monitored by radar and DIC.

Fig. 1. Test structure and radar-DIC sensing

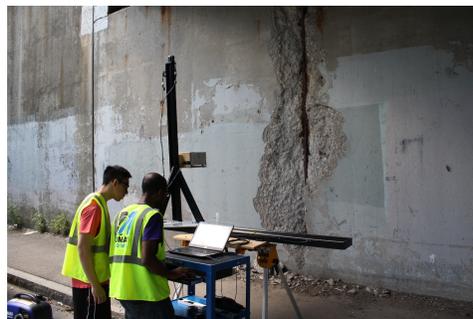
(b) Radar imaging of bridge abutment

developed for locating subsurface steel rebars in bridge abutment. Fig. 1 (c) shows the data collection scheme of the imaging radar sensor. Instrumentation of both sensors can be either portable or hand-held.

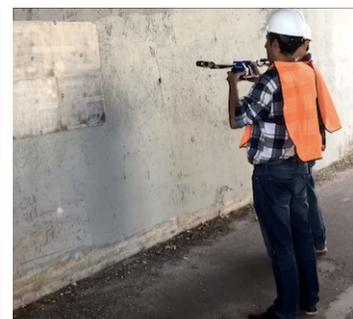
(c) DIC sensing of bridge abutment

A commercial DIC sensor (Aramis®, Trilion Quality Systems and GOM mbH) was used to monitor long-term displacement and surface distressing of bridge abutment. Fig. 1 (b) shows the data collection scheme of the DIC sensor. In our current measurement scheme using DIC, a stochastic pattern needs to be applied to the surface of interest in order to take a series of photographs are taken by both cameras of the surface at different deformation levels. A custom-built imaging radar sensor (center frequency = 10 GHz, bandwidth = 4 GHz) based on stripmap synthetic aperture radar (SAR) imaging algorithm [1] was

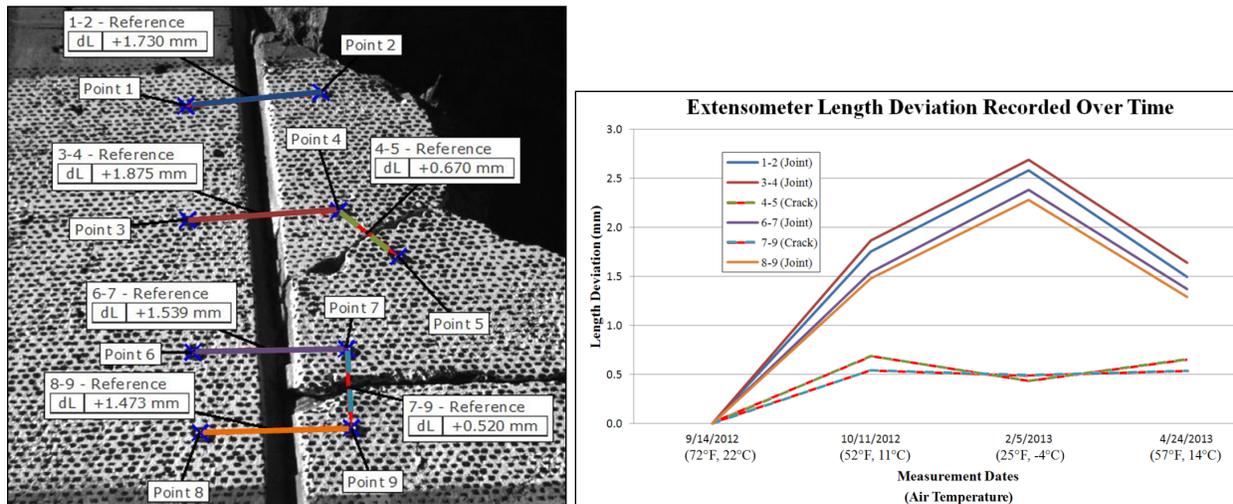
Fig. 3. (left) Photograph of bridge abutment with nine photogrammetric targets denoted by blue X's and extensometers between targets indicated by color-coded lines. (right) Length deviation of photogrammetric target extensometers monitoring joint and cracks widths on a bridge abutment.

In Fig. 3, the solid lines represent length deviations of extensometers measuring across the joint between the abutment and retaining wall, and the dashed lines represent measurements across cracks. Fig. 3 shows the joint between the abutment and retaining wall opened to a maximum of approximately 2.5mm in February and at last measurement (04/24/13) was approximately 1.5mm wider than the initial joint width measured in September. The opening of the joint is likely caused by thermal contraction of the concrete, not damage. Both cracks have opened approximately 0.5mm and are currently fluctuating around that width. Unlike the joints, the crack widths do not appear to correlate with temperature and therefore could indicate some permanent deformation from damage has occurred. These results show that long term monitoring of relative displacements can be performed using photogrammetric targets.

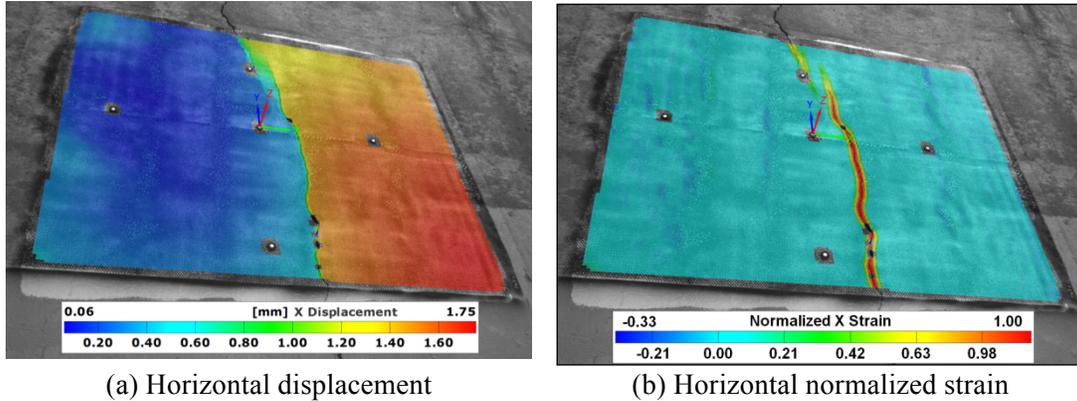
Fig. 4. Full-field horizontal displacement and strain of bridge abutment (from 09/13/12 to 02/02/13).

Fig. 4 provides the monitored displacement and normalized stress in the horizontal direction (in-plane). The result indicates the growth of a crack on the bridge abutment.

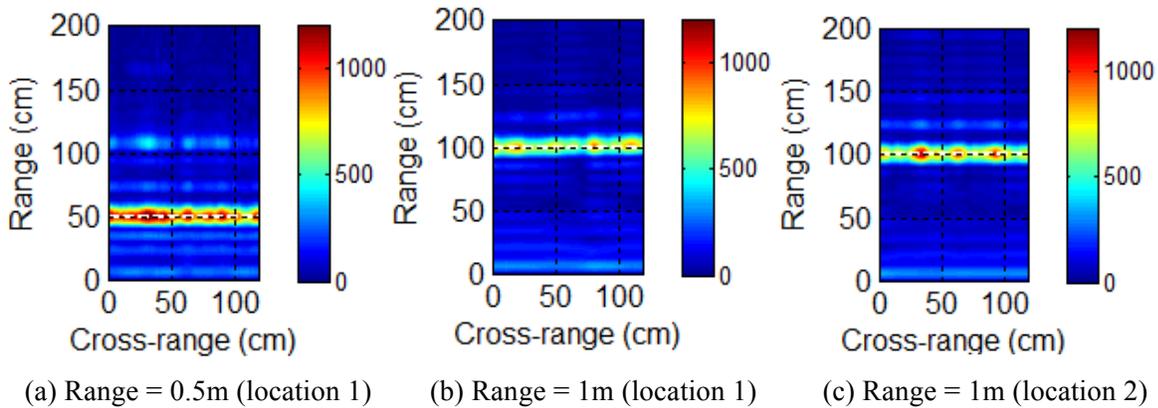
Fig. 5. SAR images at different ranges and different locations on the bridge abutment.

The imaging radar sensor mainly consists of a horn antenna, a modulator, and a signal amplifier. In-depth information of the test structure was reconstructed by SAR imaging and rendered in the range--cross-range plane. The range axis is the radar line-of-sight direction, while the cross-range axis is the direction the radar sensor travels. Fig. 5 shows in-depth radar images of three locations (1 and 2) at ranges = 0.5m and 1m. In Fig. 5, the part of SAR image on the range axis beyond the target location indicates the subsurface region of the target. For instance, the SAR image beyond range = 0.5m (50cm) in Fig. 5(a) is the subsurface region. A white-dashed line is added to the SAR images in Fig. 5 to indicate the location of bridge abutment surface line. In these SAR images, the amplitude indicates level of electromagnetic

reflection from both the surface and subsurface regions. In Fig. 5(a), both surface reflection from concrete and subsurface reflection from steel rebars are present, while in Figs. 5(b) and (c) the subsurface reflection (shown in red scatterers) becomes dominant. Five steel rebars are identified in these SAR images.
